CASE STUDY SMARTDITCH.COM

SMARTDITCH ELIMINATES SEVERE SLOPE-SIDE EROSION AT LANDFILL WITH 145 FT. ELEVATION

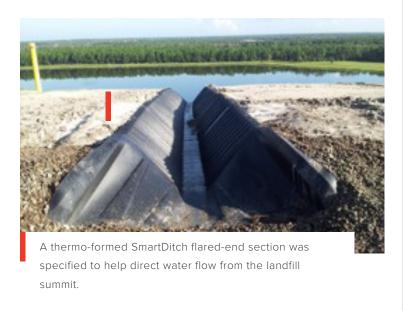
500 LF of 24" SmartDitch was installed to eliminate this landfill's perpetual slope side erosion problems, caused by large amounts of water build-up from the landfill's summit.

A 500 LF vertical downhill run of 24" depth trapezoidal SmartDitch was installed as the primary stormwater run-off and erosion control channel. Two flared-end sections were added to help guide the water flow at the top, and evenly disperse the run-off water into a rock line holding area at the bottom.
