# SMARTDITCH STOPS EROSION IN GOLDSBORO, NC NEIGHBORHOOD

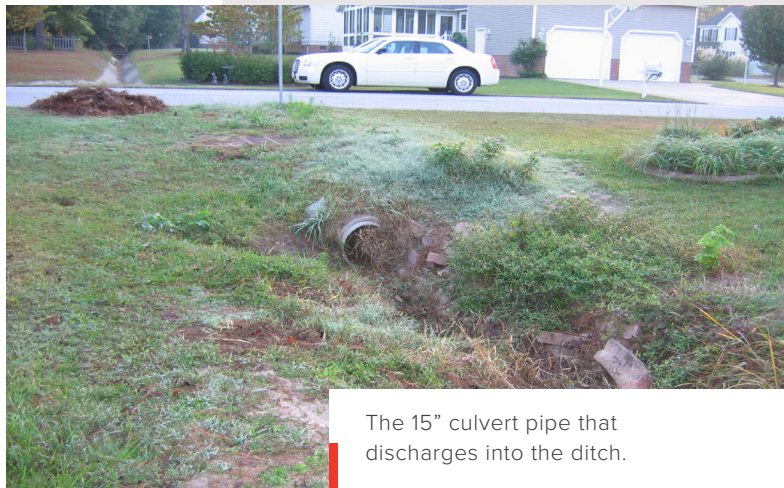
The 15" culvert pipe that discharges into the ditch.

On a recent project in Goldsboro, NC, SmartDitch was installed in a residential area that had drainage and erosion problems. A 15" concrete culvert pipe was discharging storm water into an earthen ditch behind houses and during heavy rain events washing out their yards. In the past, rip rap had been placed at the end of the culvert pipe to dissipate the energy of the flow with limited success. The local municipality reviewed and chose SmartDitch as a solution to stop the erosion and improve the drainage situation.

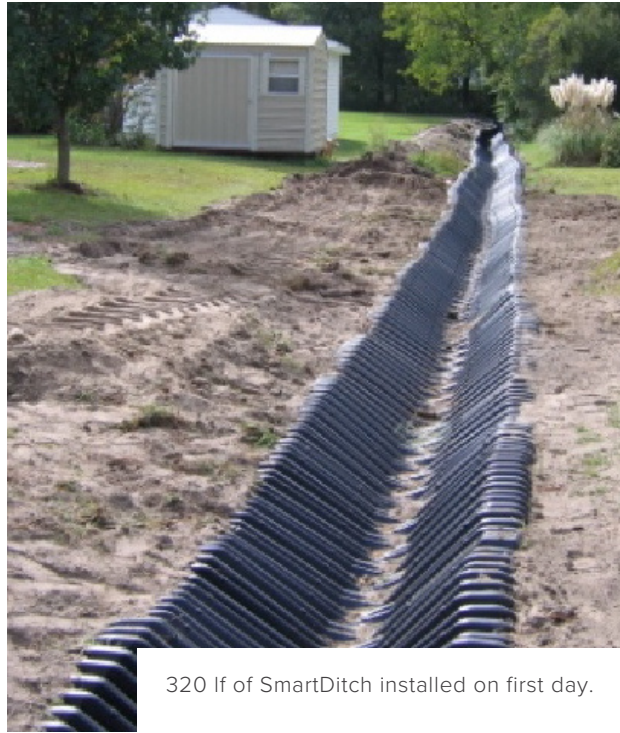
320 lf of SmartDitch installed on first day.

The decision to utilize SmartDitch was tested on the first day of construction. The 320 feet of SmartDitch was installed on the first day and the crew finished the day with only the need to complete finished grading and clean-up on the second day. That evening, a heavy rain event occurred and provided the first test of the new system. In less than two hours, over 3" of rain occurred and overloaded the entire neighborhood drainage system.

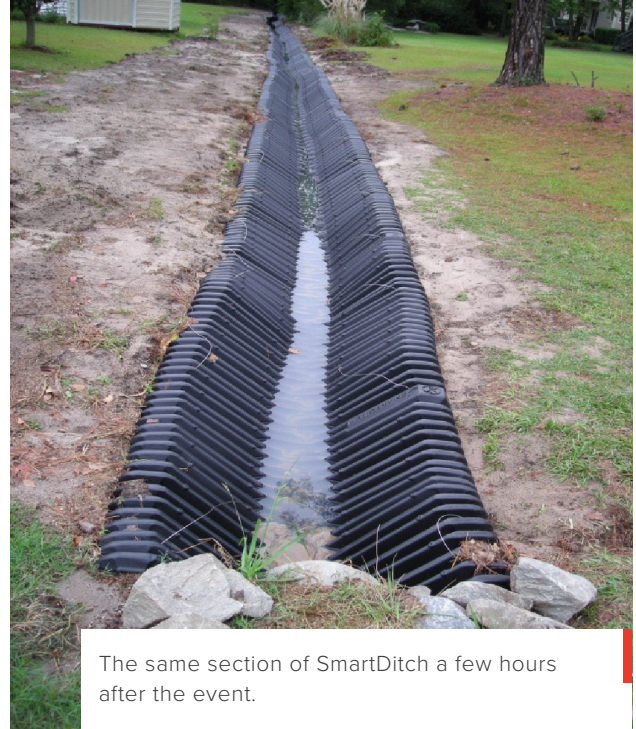
The same section of SmartDitch a few hours after the event.

The 15" concrete culvert pipe emptying into the SmartDitch sections was flowing at 100% capacity during the event with the flows exceeding the 12" Trapezoidal section's flow capacities. The water flowed over the side walls of the SmartDitch sections but because the energy of the flow was dissipated by the corrugated side walls, no erosion occurred. The integrity of the ditch was maintained and the water moved quickly away from the residences, preventing serious flooding and damage. As the rain event subsided, the water that flowed over the sides drained back into the SmartDitch with no erosion occurring on the sides.
