# SMARTDITCH® REPLACES FAILED RIP RAP AT MDOT “PARK ‘N RIDE” LOCATION.

INSTANT IMPROVEMENT IN STORMWATER FLOW AND EROSION CONTROL REALIZED.

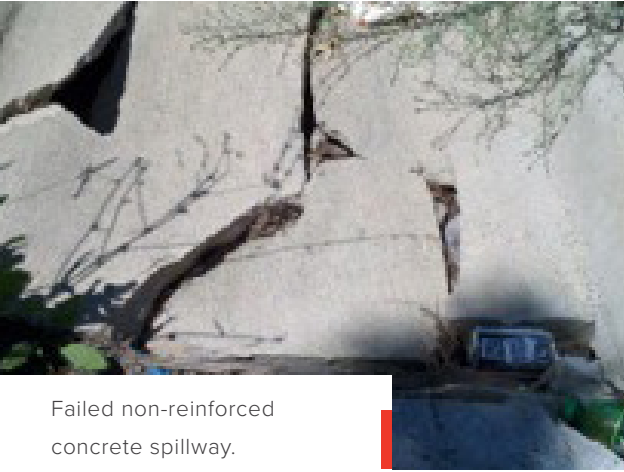
Failed non-reinforced concrete spillway.

A non-reinforced concrete spillway and multiple rip rap applications failed after one year, causing flooding and erosion at a local Park ‘n Ride commuter location maintained by the MDOT Brighton Service Garage.

A new reinforced concrete spillway and SmartDitch drainage channel was installed to replace the failed N-RCP and the continuously scouring rip rap.

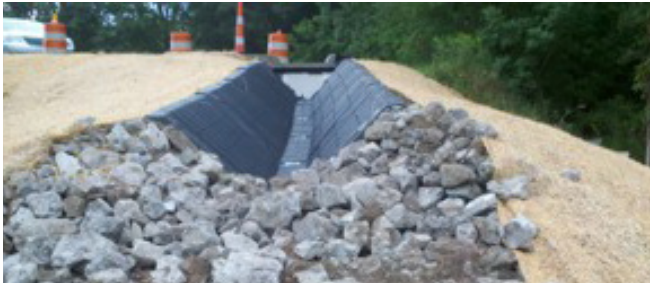
Completed spill with SmartDitch and repurposed rip rap.

70 LF of 24” trapezoidal SmartDitch was to replace the rip rap section of the spillway. It only took two days to install and eliminated a year-round drainage, maintenance, and aesthetic issue. No special equipment was required for installation and the product was delivered from Michigan’s SmartDitch Distributor, St. Regis Culvert, to the site in the back of a standard pick-up truck.

Since SmartDitch is a permanent solution, it is more cost-effective, requires little-to-no maintenance, and will not promote vegetated growth in its channels. Additional savings were achieved by re-purposing the existing rip rap at the downstream end of the SmartDitch channel.

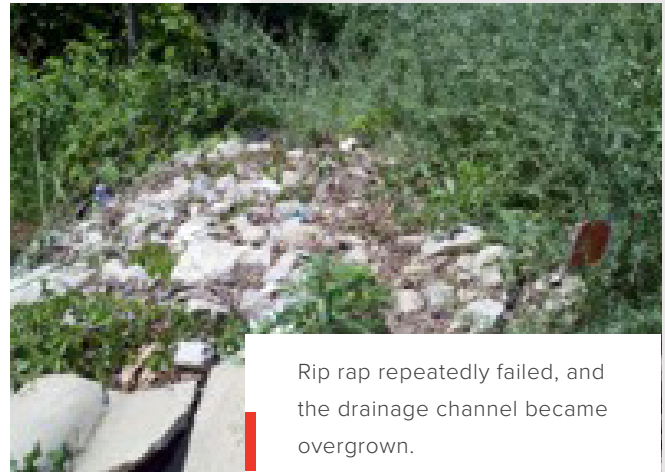
Rip rap repeatedly failed, and the drainage channel became overgrown.
