MONTGOMERY CREEK STREAM RESTORATION

Project Details

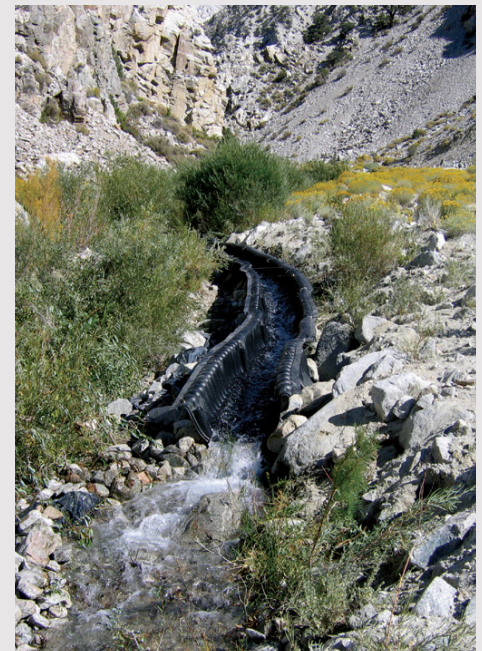
- **PROJECT NAME:** Montgomery Creek Stream Restoration
- **PROJECT LOCATION:** Benton, California
- **OWNER ORGANIZATION:** Montgomery Creek Ranch Owner: Dave Doonan, Bishop, CA
- **PRODUCT DETAILS:** 24" Semi-Circular SmartDitch Setting on Saddles
- **ANCHORING SYSTEM :** Standard Anchoring System
- **JOINT TYPE(S) :** Gasketed Joint
- **PROJECT TYPE :** New Installation

SmartDitch's lightweight design allowed for easy transportation of the ditch system into the White Mountain region. Access to the project site was available only on a narrow rock lined trail, and the product needed to be transported on a small trailer pulled behind a four wheel Jeep. The fissure that crossed the stream disrupted the flow of the water for approximately 80 feet. The existing stream bed was mainly rock surrounded by small stones and boulders. To facilitate the installation of SmartDitch, the 24" Semi-Circular product was chosen due to its ability to be cradled in saddles and installed above ground. During construction the water flow was diverted by make shift dams around the

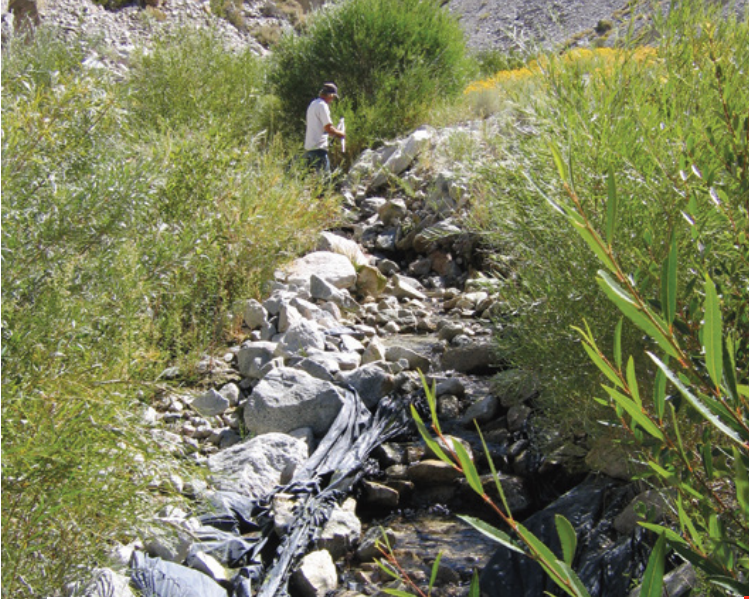
During an earthquake, a fissure had opened across the Montgomery Creek which allowed water to flow back into the ground. Previous attempts to rehabilitate the existing system bed included using a steel slough and polyethylene film.

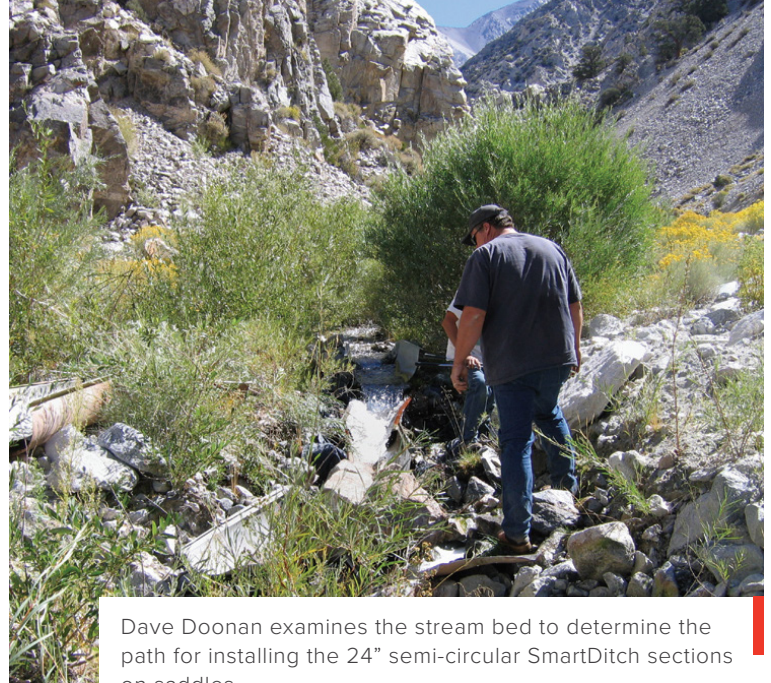
Dave Doonan examines the stream bed to determine the path for installing the 24" semi-circular SmartDitch sections on saddles.

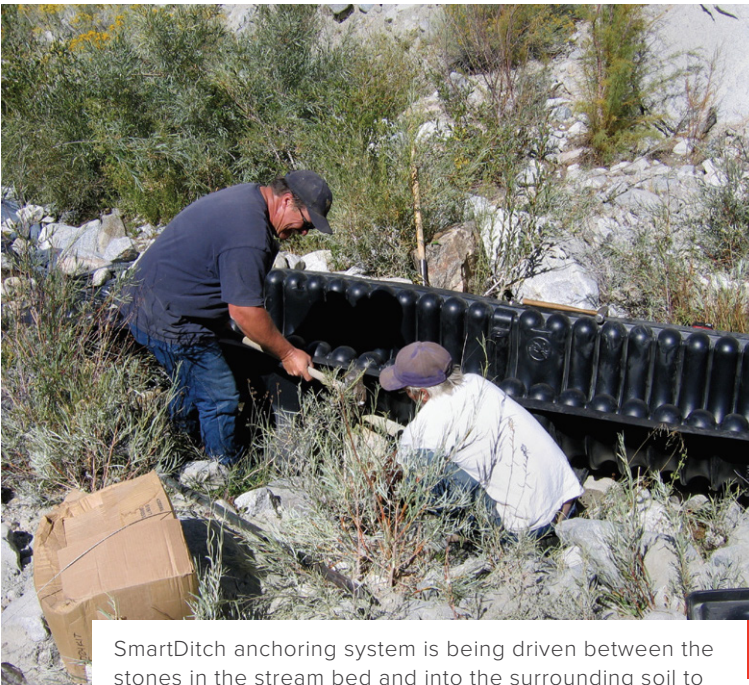
SmartDitch anchoring system is being driven between the stones in the stream bed and into the surrounding soil to provide a solid footing for the sections.

stream bed and the SmartDitch sections were laid on the saddles. SmartDitch's standard anchors were utilized by driving them between the stones in the stream bed into the surrounding soil. To provide an additional measure of protection to the channel sections, stones and boulders were stacked up along side the SmartDitch. At the upstream end of the SmartDitch sections, stones were used to direct the flow of the stream into the SmartDitch channels. The flow of water in the stream was restored to its original course.

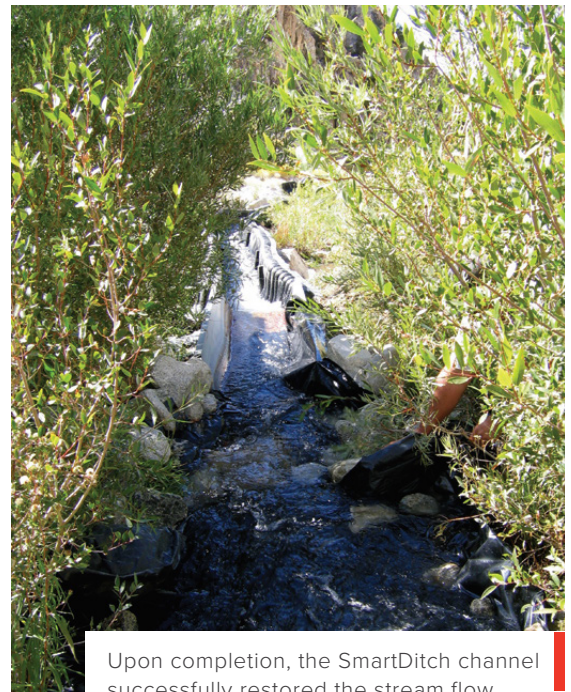
Upon completion, the SmartDitch channel successfully restored the stream flow back to natural path down the mountain.
