CASE STUDY SMARTDITCH.COM

IRON HORSE INN DITCH REHABILITATION

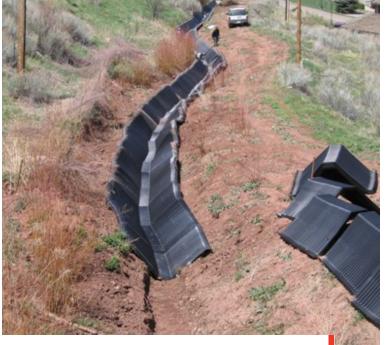
Site overview during construction. Photo shows the installation after the first day. The sections have been installed in the ditch with additional sections awaiting installation. This photo is prior to backfilling and final grading and shows the condition of the ditch after cleaning up the debris.

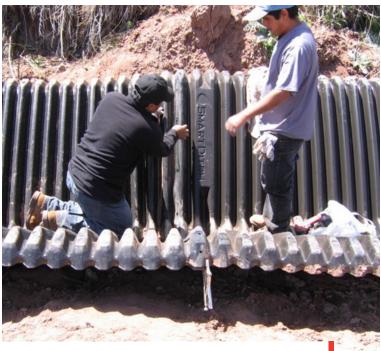
Site during installation of SmartDitch. Photo shows the quick and easy process of anchoring and installing SmartDitch sections.
