# SMARTDITCH HELPS WISCONSIN COMMUNITY SOLVE LONG-STANDING DRAINAGE & EROSION PROBLEM

LAKESIDE COMMUNITY FIGHTS POOR DRAINAGE, BATTLES ROADSIDE EROSION

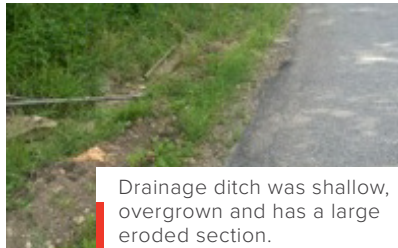
Drainage ditch was shallow, overgrown and has a large eroded section.

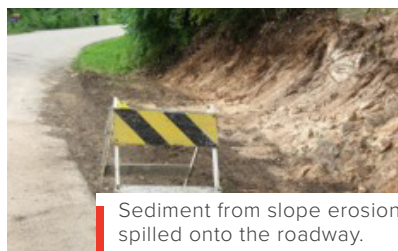
Sediment from slope erosion spilled onto the roadway.

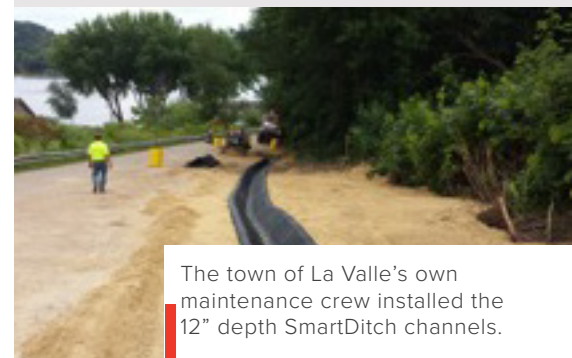
The town of La Valle's own maintenance crew installed the 12" depth SmartDitch channels.

After inspecting the ditch, Maederer presented a design to reline 130 LF of the earthen channel. The design called for 14 sections of the 12" SmartDitch channel. Each section is 9.5' in long and are overlapped, then joined together (with selftapping screws), along the length of the ditch. Once in place, the sections are secured to the ground using anchors and stainless steel cables. Estimated installation time was less than a week and it could be done by the town's own maintenance crew. The board unanimously approved the design and expense.

**Installation Goes Smoothly. Town Pleased with Results.** SmartDitch Engineers provided installation supervision to ensure the town's maintenance crew installed the product properly. Including ditch cleaning, filling in eroded areas and excavation, the installation took only 5 days to complete.

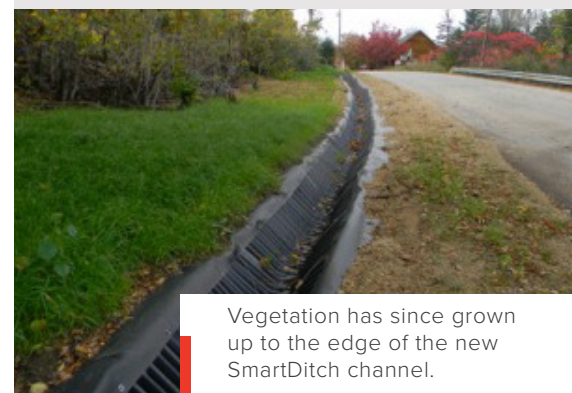
Vegetation has since grown up to the edge of the new SmartDitch channel.

For added erosion control, 30 mil HDPE Edge protection was installed on both sides of the channel to prevent erosion along the SmartDitch edges.
