CASE STUDY SMARTDITCH.COM

## SMARTDITCH REPLACES FAILED RIPRAP CHANNEL TO SOLVE WISCONSIN DOT OVERPASS DRAINAGE PROBLEM.

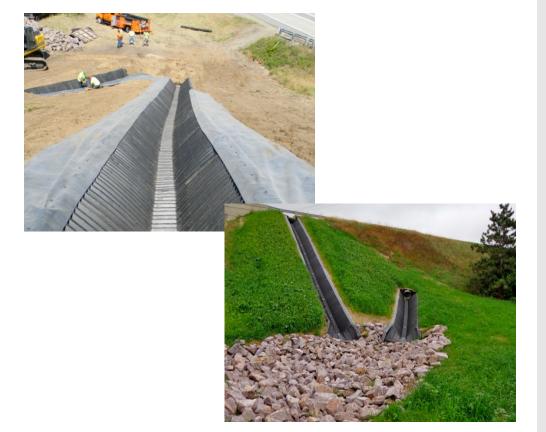
The SmartDitch System. For this particular situation the 24"depth, trapezoidal-shaped channel with it's ribbed design and ability to handle the flow capacity on this 3:1 slope, eliminated the problem.

- SmartDitch was installed to eliminate a severe stormwater runoff situation, where flooding and erosion were undermining the road above, and the underpass below.
- An excellent flow control solution
   The effected slope's pitch was approximately 3:1 (horizontal to vertical) on the longer ditch and 5:1 on the shorter ditch section.
- ◆ Installs quickly and cost- effectively Only 107 feet of 24" SmartDitch was required to reline both ditches. The installation was performed by the Colombia County Highway Maintenance Crew, and took only two days to complete -- which included the removal of the failed rip rap and the excavation of both ditches.
